Report No. FAA-SS-72-07

**SST Technology
Follow-On Program—Phase I
TITANIUM ALLOY 6AL-4V HYDROGEN EFFECTS**

Fred L. Parkinson
The Boeing Company
Commercial Airplane Group
P.O. Box 3707
Seattle, Washington 98124

**FINAL REPORT
TASK I**

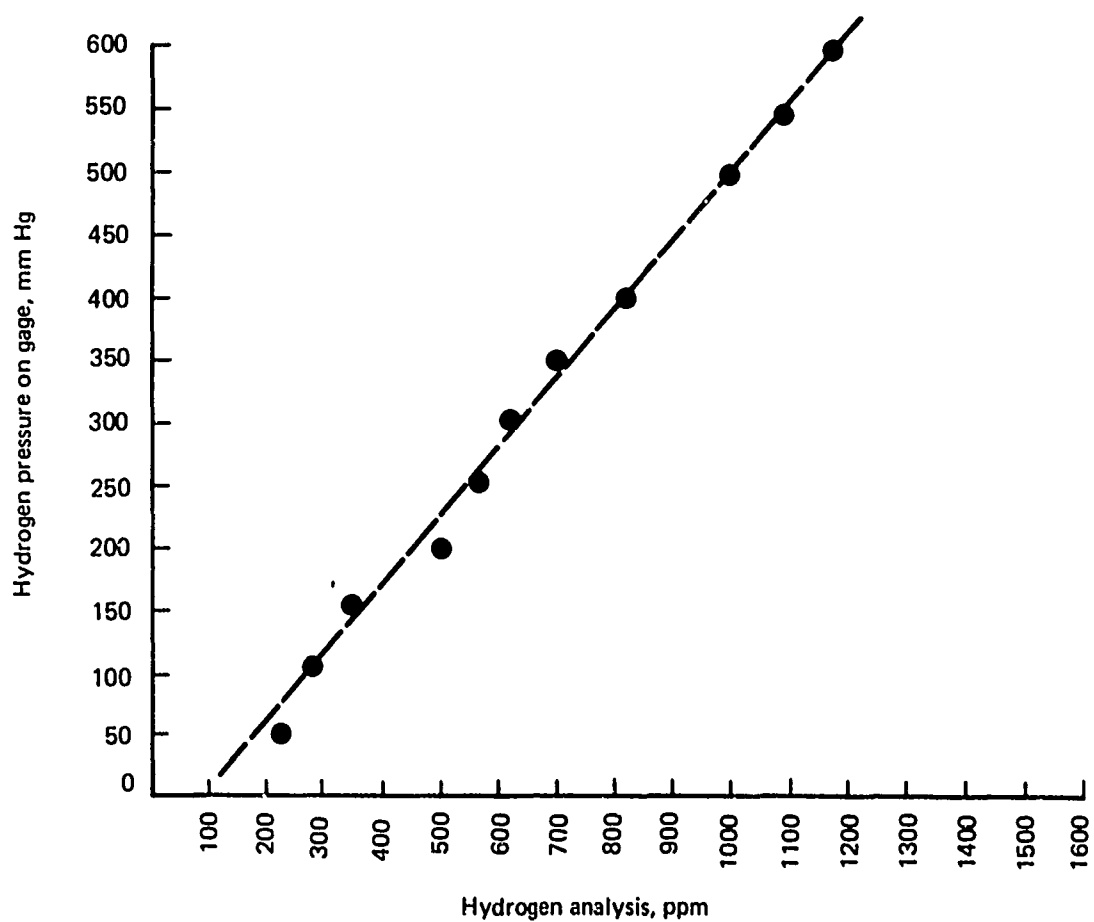
FIGURE 2.—EFFECT OF HYDROGEN CONTENT ON GAGE PRESSURE FOR A CHARPY SPECIMEN

The fracture specimens were charged with hydrogen in a modified Sievert's apparatus by exposing them to a given partial pressure of hydrogen at elevated temperatures. Relatively reliable curves were developed which related the resulting hydrogen content in the titanium sample versus hydrogen pressure. The curves had to be modified for various sizes and shapes of test specimens, but once established, they were reasonably accurate in predicting the final hydrogen in the specimen. It was found that a surface pickling step prior to charging and a very clean vacuum system were both necessary for a successful charge. The pickling solution was 90% HNO_3 , 10% HF at room temperature. The presence of an oxygen layer inhibited the transfer of molecular H_2 to atomic H and into solution with the titanium. Because successful charging could not be accomplished at 1000° F, all hydrogenation was accomplished at 1250° F. This temperature was of course unacceptable for charging condition III (solution treated and aged at 1000° F) since overaging would occur. The charging of the condition III specimens was therefore accomplished by charging at 1250° F and then solution treating at 1725° F in air. The oxide layer which formed at 1725° F prevented the outgassing of hydrogen at this temperature. The samples were then aged at 1000° F.

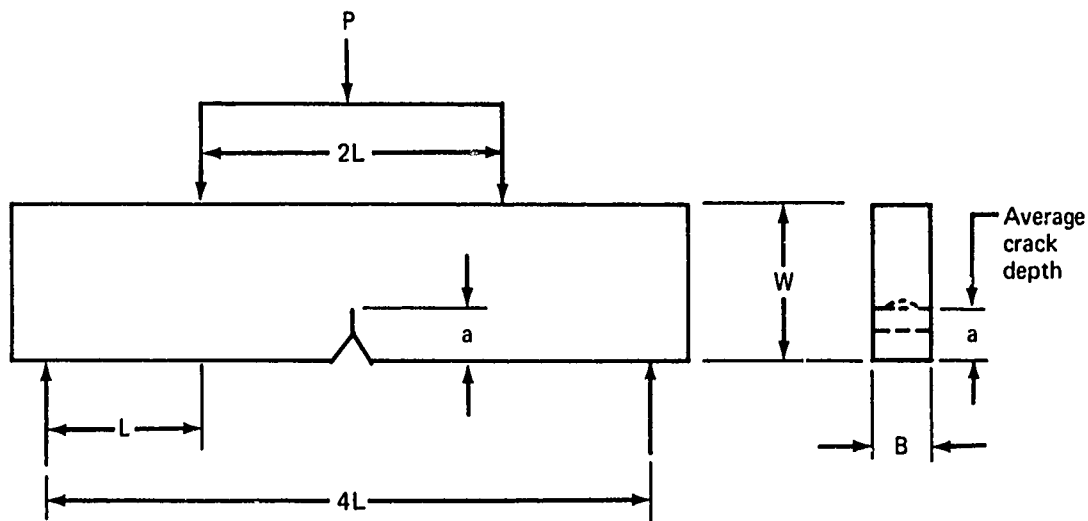
$$\sigma_N = \text{net area stress} = \frac{M_c}{I}, \text{ where } M = L \frac{P_{DL}}{2} \text{ and } I = \frac{B(w-a)^3}{12}$$

$L = 1.5$ in.
 $B = 0.480$ in.
 $w = 1.5$ in.

FIGURE 3.—FOUR-POINT-LOADED, NOTCHED, BEND FRACTURE SPECIMEN FORMULAS

Four-point-loaded, notched bend specimens were used to determine K_{Ic} as shown in figure 3, which gives the specimen configuration and fracture toughness formulas used. The loading rate was 1000 psi/sec. The hydrogen content was varied from 200 to 750 ppm.

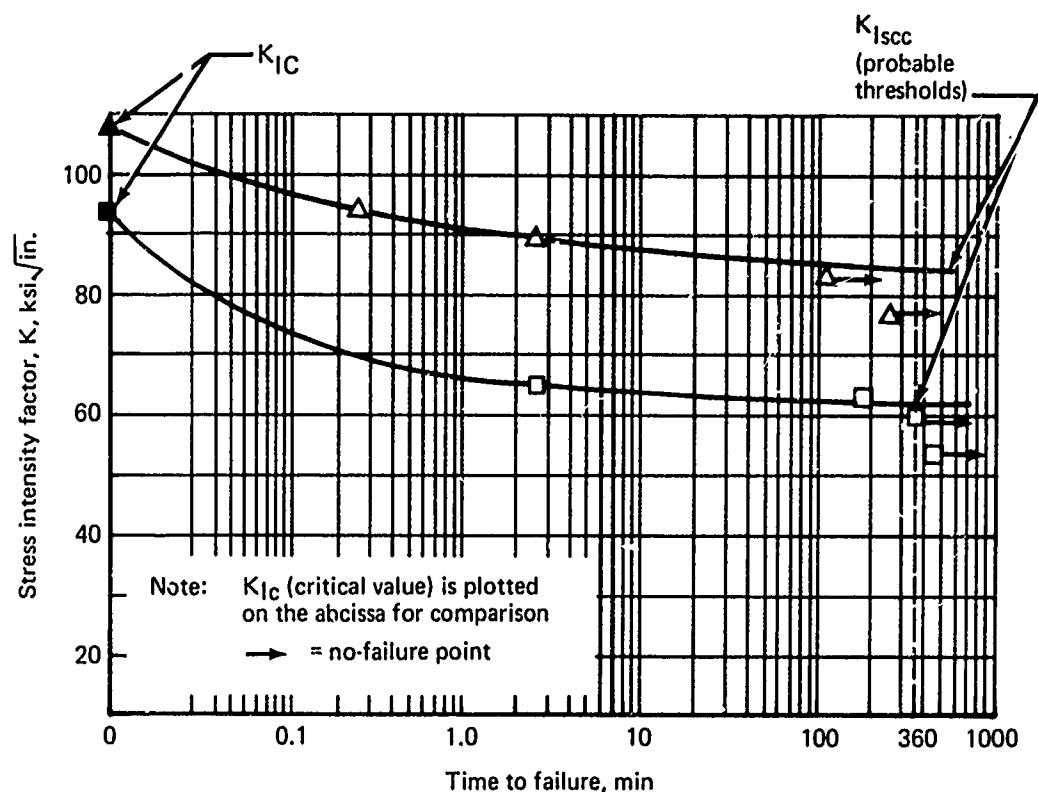
FIGURE 4.—STRESS-CORROSION (K_{Isc}) THRESHOLD LEVEL CURVES

Stress corrosion, K_{Isc} , tests were conducted using the same specimen configuration, material, and hydrogen content levels as those described in 2.1.2.1. To determine K_{Isc} , sustained loading was applied to the precracked, notched bend specimens in 3.5% NaCl solution either for 360 min or until failure at a stress intensity, K , level as calculated from figure 3. Except for series 750HT, which used only two specimens, three specimens were tested at various K levels and threshold curves were plotted as shown in figure 4. In some cases specimens that did not fail after 360 min were fatigue cracked again and sustained loading applied at higher K levels to obtain more data. From curves such as those shown in figure 4 the K_{Isc} threshold level was determined.

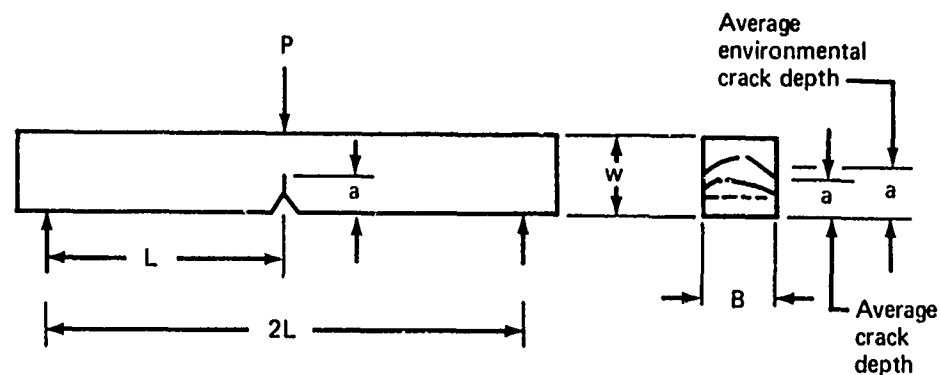
$$\delta N = \text{net area stress} = \frac{M_c}{I}, \text{ where } M = \frac{LP_{max}}{2} \text{ and } I = \frac{(W-a)^3}{12}$$

$L = 0.82$ in.
 $B = 0.394$ in.
 $W = 0.394$ in.

FIGURE 5.—PRECRACKED CHARPY DELAYED-FAILURE TESTING SPECIMEN FORMULAS

Delayed-failure tests were conducted by sustained loading in room temperature air of precracked specimens charged with various levels of hydrogen. The tests were conducted for either 2500 or 5000 hr or until failure. Two types of specimens were used: the precracked Charpy specimen for Ti-6Al-4V plate and the single-edge-cracked specimen for Ti-6Al-4V sheet. The specimen configuration and formulas are shown in figures 5 and 6, respectively (ref. 3.)

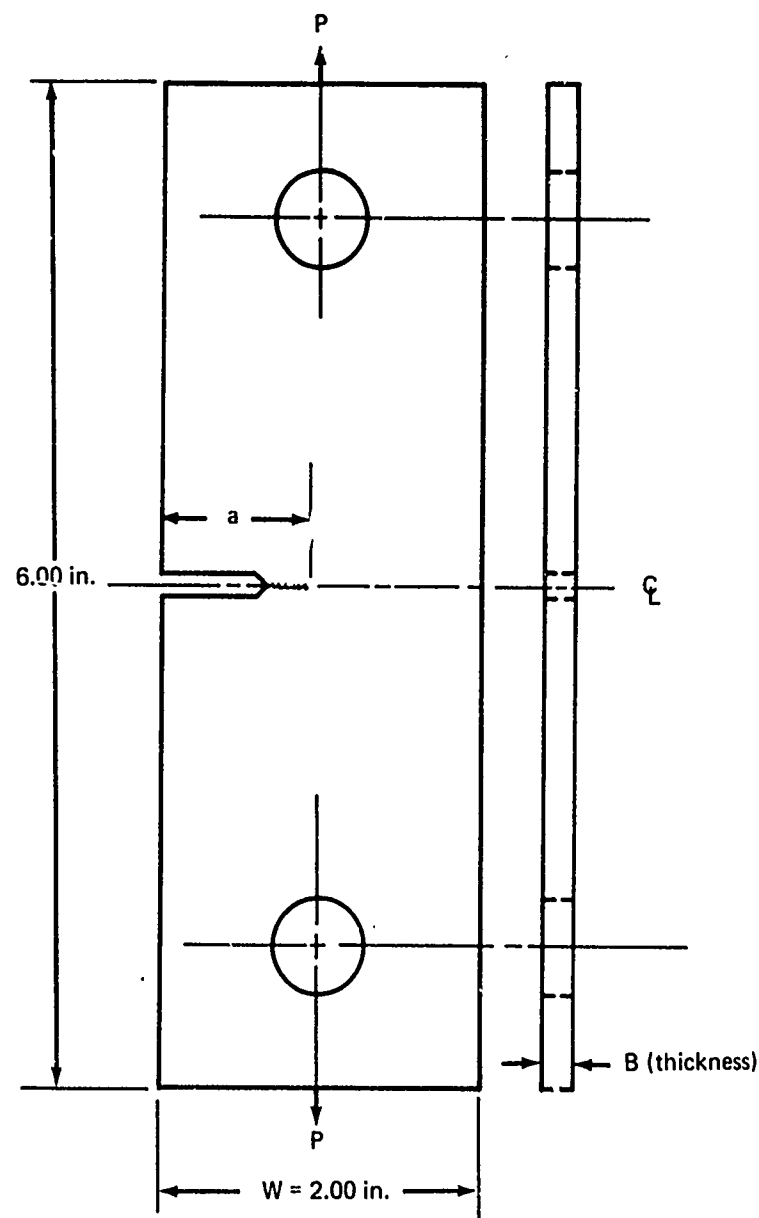
$$k = \frac{Pa^{1/2}}{Bw} \gamma$$

$$\text{where } \gamma = 1.99 - 0.41\left(\frac{a}{W}\right) + 18.70\left(\frac{a}{W}\right)^2 - 38.48\left(\frac{a}{W}\right)^3 + 53.85\left(\frac{a}{W}\right)^4 \quad (\text{ref. 3})$$

FIGURE 6.—SINGLE-EDGE-CRACKED SPECIMEN USED FOR DELAYED-FAILURE TESTING

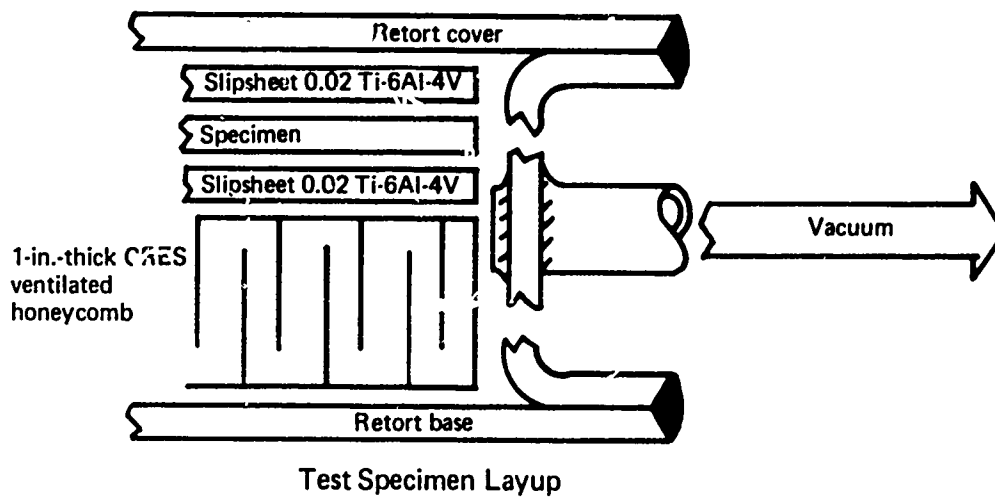
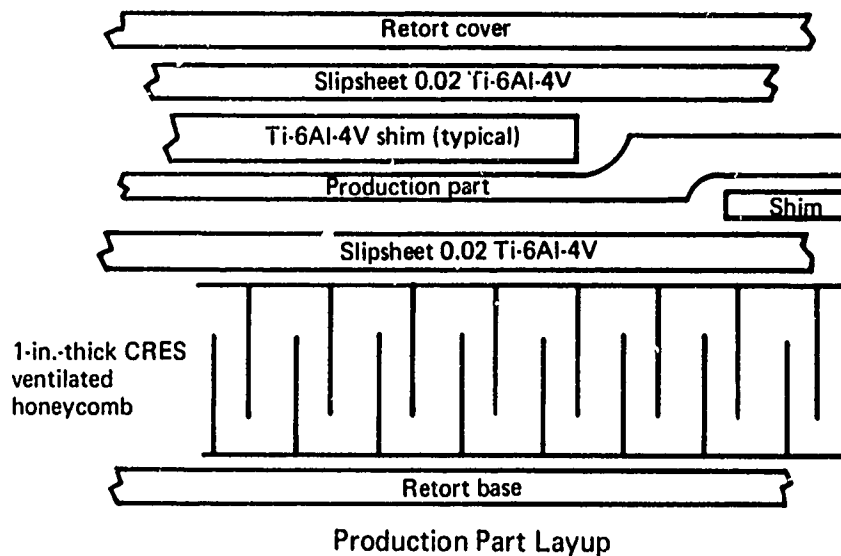
FIGURE 7.—TYPICAL VACUUM RETORT ASSEMBLY FOR ELEVATED-TEMPERATURE HYDROGEN REMOVAL

The small retort tests were intended to verify that hydrogen could be removed without causing indenting from honeycomb core or other physical damage to a thin part. Figure 7 compares the cross section of the retort layup used for degassing tests and the retort layup anticipated for production parts.

Retorts were sealed by welding and leak checked prior to the degassing tests. Purging of the welded retort assembly (fig. 7) was performed during heatup in accordance with XBAC 5967 (ref. 7) and Product Manufacturing and Assembly Manual 6M 64-053 (ref. 8), "Brazing Titanium Honeycomb Sandwich Structure." This procedure consisted of a series of vacuum purges and argon backfills until 800°F was reached. A constant vacuum level of 50 torr was maintained at temperatures above 800°F and during cooldown to 300°F.

The small retort test results are summarized in figure 25, which shows 1150°F to be the lowest temperature, for 1 hr at 50 torr vacuum, that will effectively remove hydrogen with the layup shown in figure 7. It was also demonstrated that an 0.020-in. Ti-6Al-4V separator was adequate to prevent the stainless steel honeycomb from indenting the test specimen.

The vacuum retort assembly shown in figure 7 is adequate to reduce hydrogen levels to below 150 ppm in Ti-6Al-4V. However, additional testing will be required to verify that all areas of a large panel can be degassed to this level. The procedure schedule developed to date is:

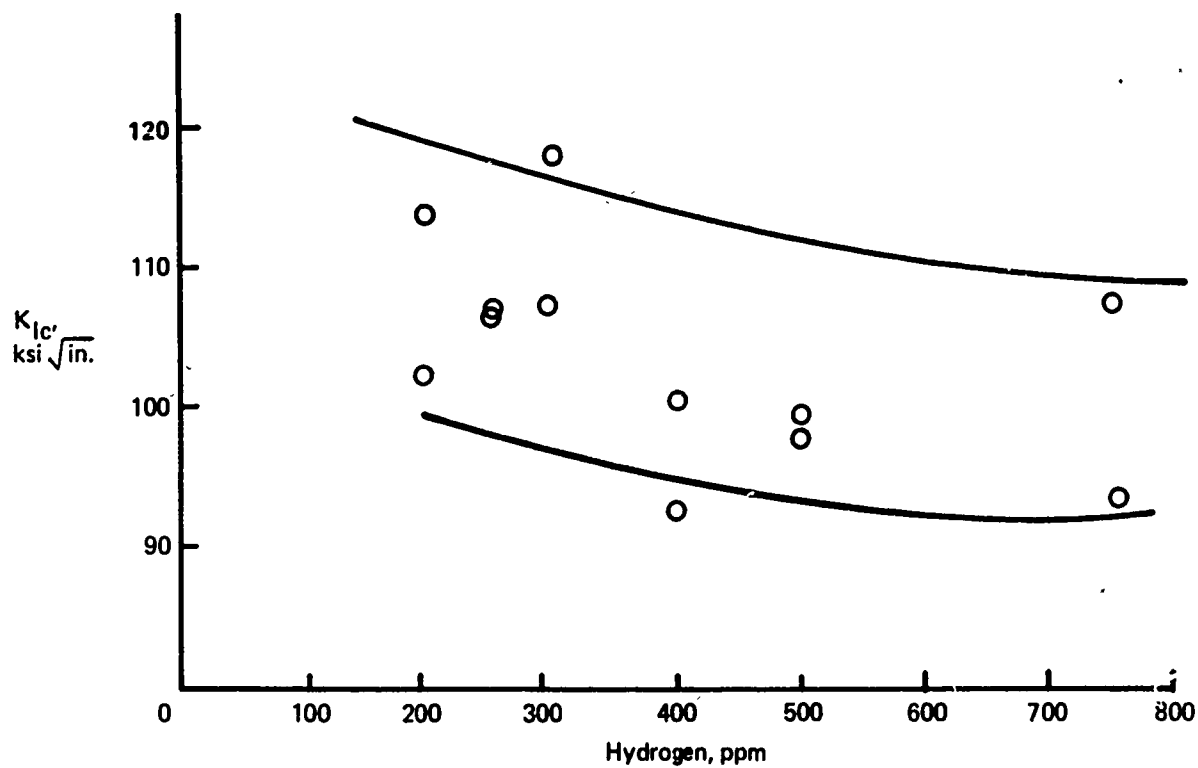
FIGURE 8.—EFFECT OF HYDROGEN ON K_{Ic} OF BETA-MILL-ANNEALED Ti-6Al-4V

The fracture toughness results are shown in table 2 for hydrogen contents of 200-750 ppm for both beta-mill-annealed and beta-STA 1250°F Ti-6Al-4V. These results are plotted in figures 8 and 9. In general, hydrogen has little effect on the K_{Ic} of Ti-6Al-4V for either of these heat treatments. There appears to be a slight downward trend with increasing hydrogen content. This trend is somewhat more pronounced for beta-STA 1250°F than for beta-mill-annealed Ti-6Al-4V. However, considering the rather unusual scatter in the data this trend is probably not statistically significant. It is remarkable that even at very high hydrogen contents of 300-750 ppm the K_{Ic} for Ti-6Al-4V is still greater than 92 ksi $\sqrt{\text{in.}}$ for both heat treatments.

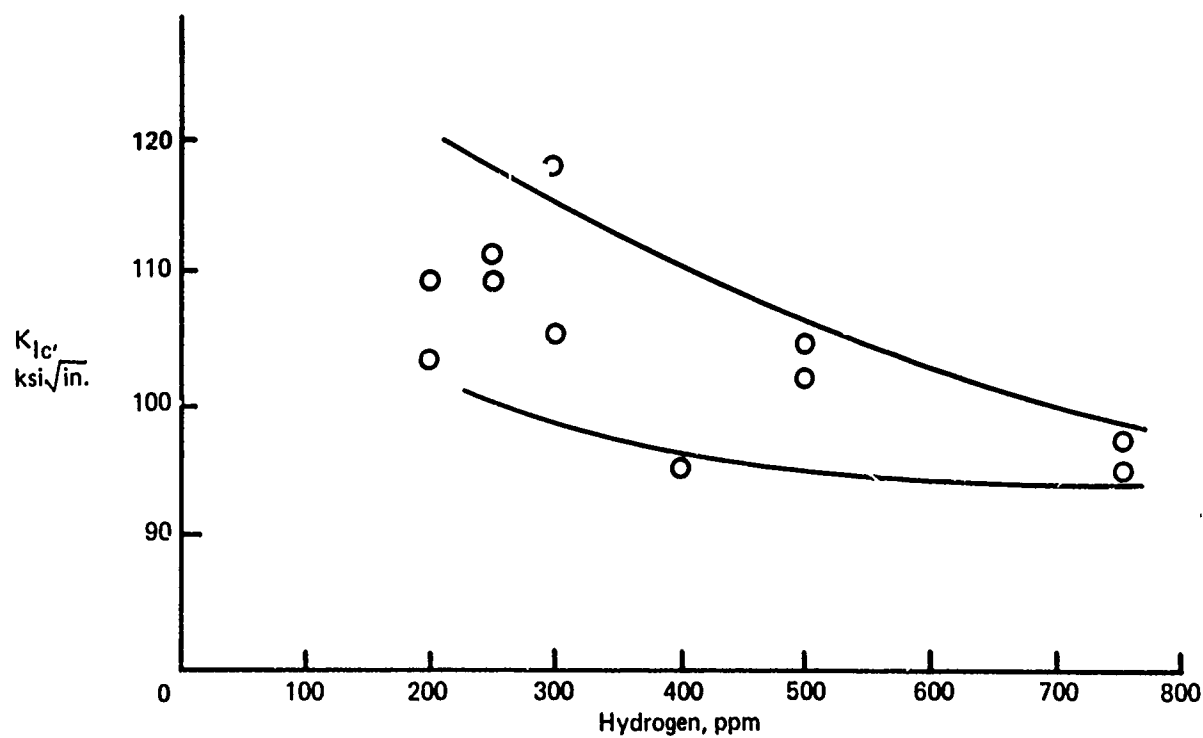
FIGURE 9.—EFFECT OF HYDROGEN ON K_{Ic} OF BETA-SOLUTION-TREATED AND AGED 1250°F Ti-6Al-4V

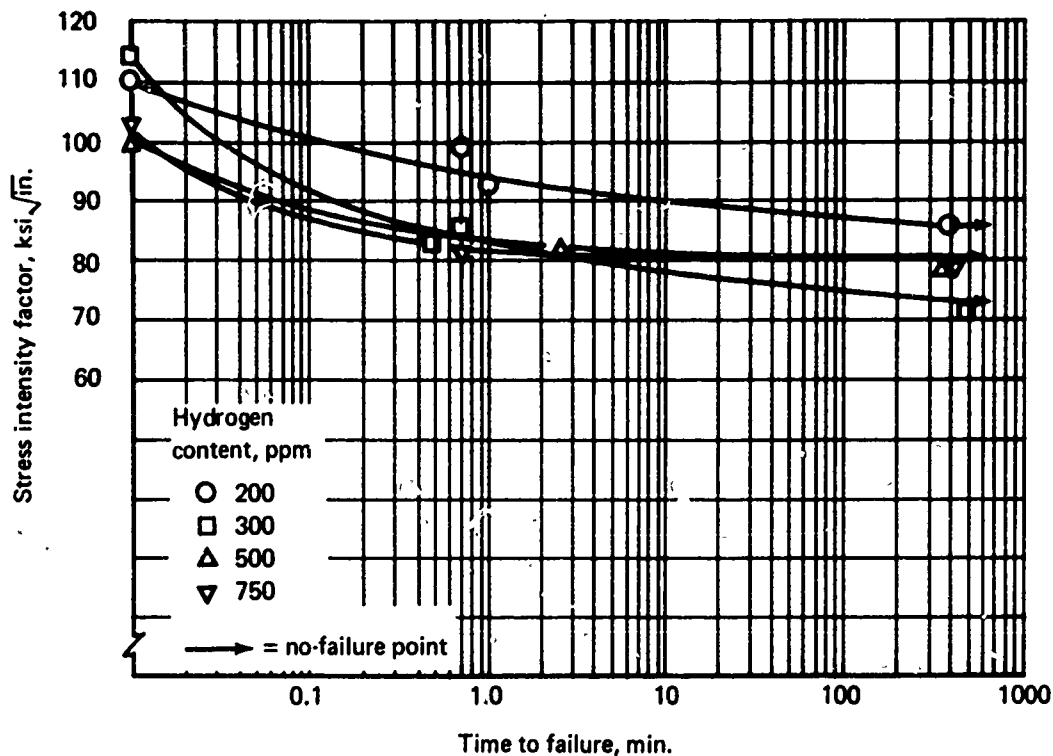
FIGURE 10.—EFFECT OF HYDROGEN ON K_{Isc} OF BETA-MILL-ANNEALED Ti-6Al-4V

The stress-corrosion test results are shown in figures 10 and 11 for beta-mill-annealed and beta-STA 1250° F Ti-6Al-4V, respectively. These data are summarized in table 3 for both these conditions. As with K_{IC} , hydrogen contents of 200-750 ppm have little effect on K_{ISCC} . The K_{ISCC} values are virtually identical for hydrogen levels of 200 ppm and 750 ppm. The relatively high K_{ISCC} values for all the levels tested is a direct result of the good microstructure (acicular or Widmanstatten) and low oxygen (0.11%) and aluminum (5.9%) contents. Much lower K_{ISCC} values have been obtained for higher oxygen and aluminum contents and for poorer microstructure (ref. 9), even though the hydrogen contents were less than 125 ppm. There was no difference in hydrogen effects between the two different heat treatments used, since the average ratio of K_{ISCC}/K_{IC} was 0.75 for both heat treatments.

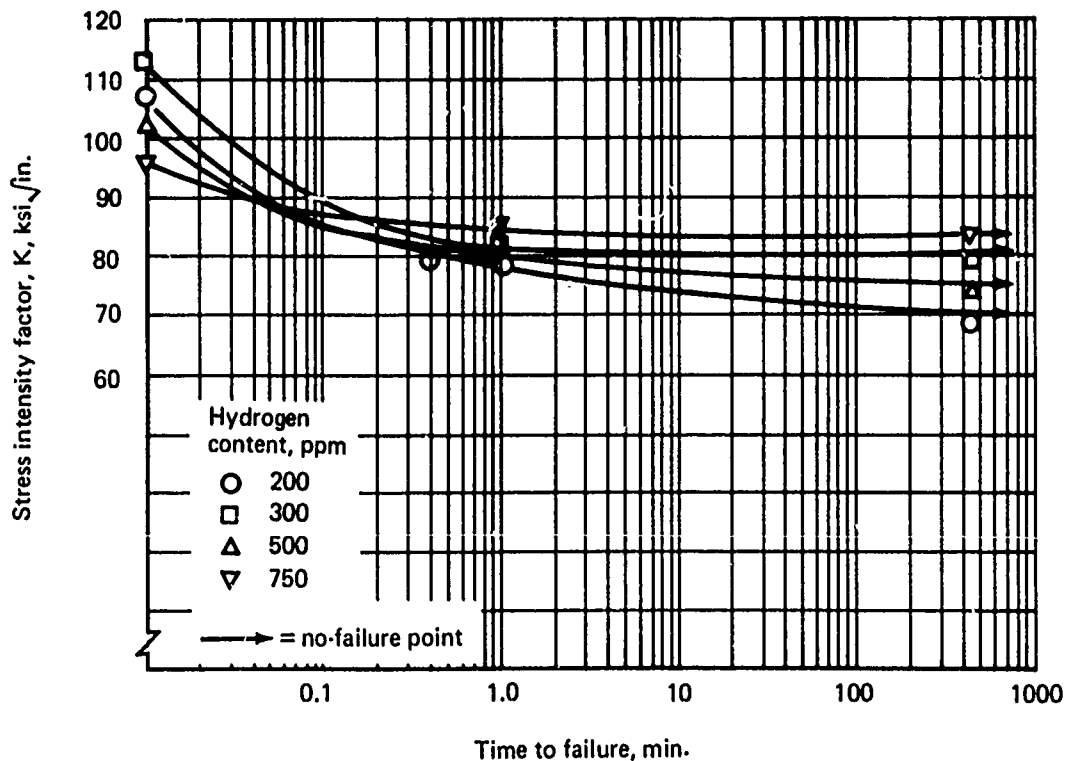
FIGURE 11.—EFFECT OF HYDROGEN ON K_{Isc} OF BETA-SOLUTION-TREATED AND AGED 1250°F Ti-6Al-4V

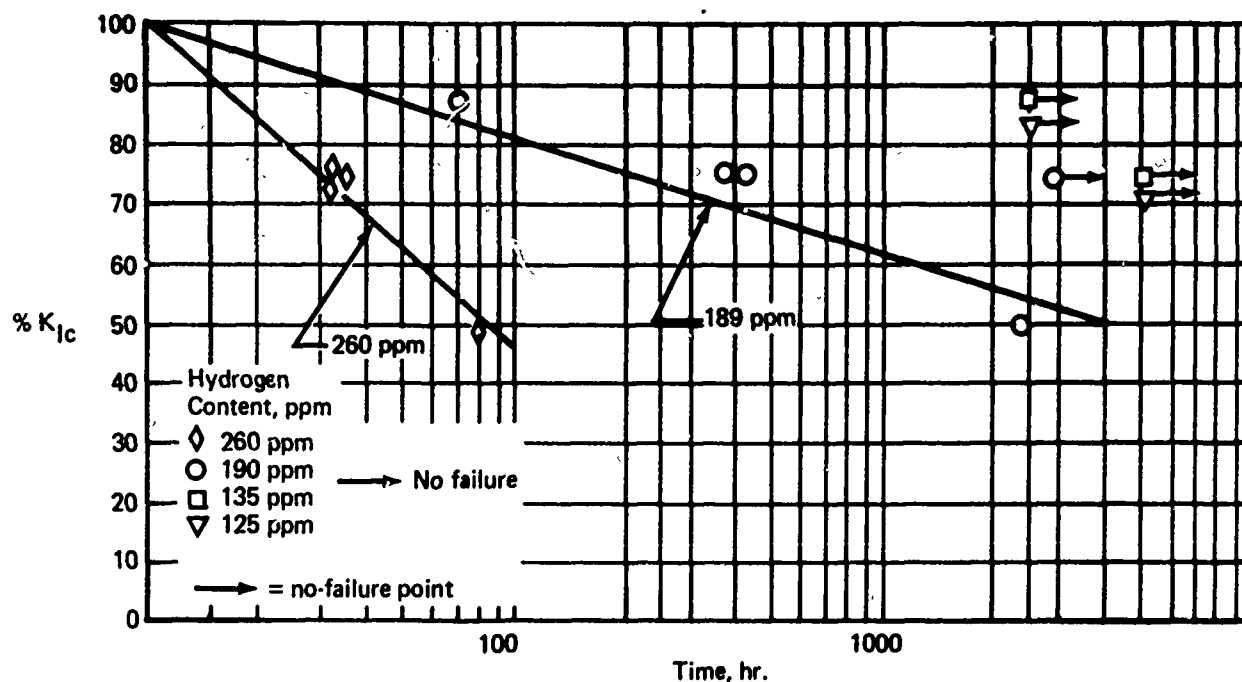
FIGURE 12.—EFFECT OF HYDROGEN ON SUSTAINED-LOAD K_{Ic} (PRECRACKED CHARPY) OF Ti-6Al-4V BETA STA 1250°F

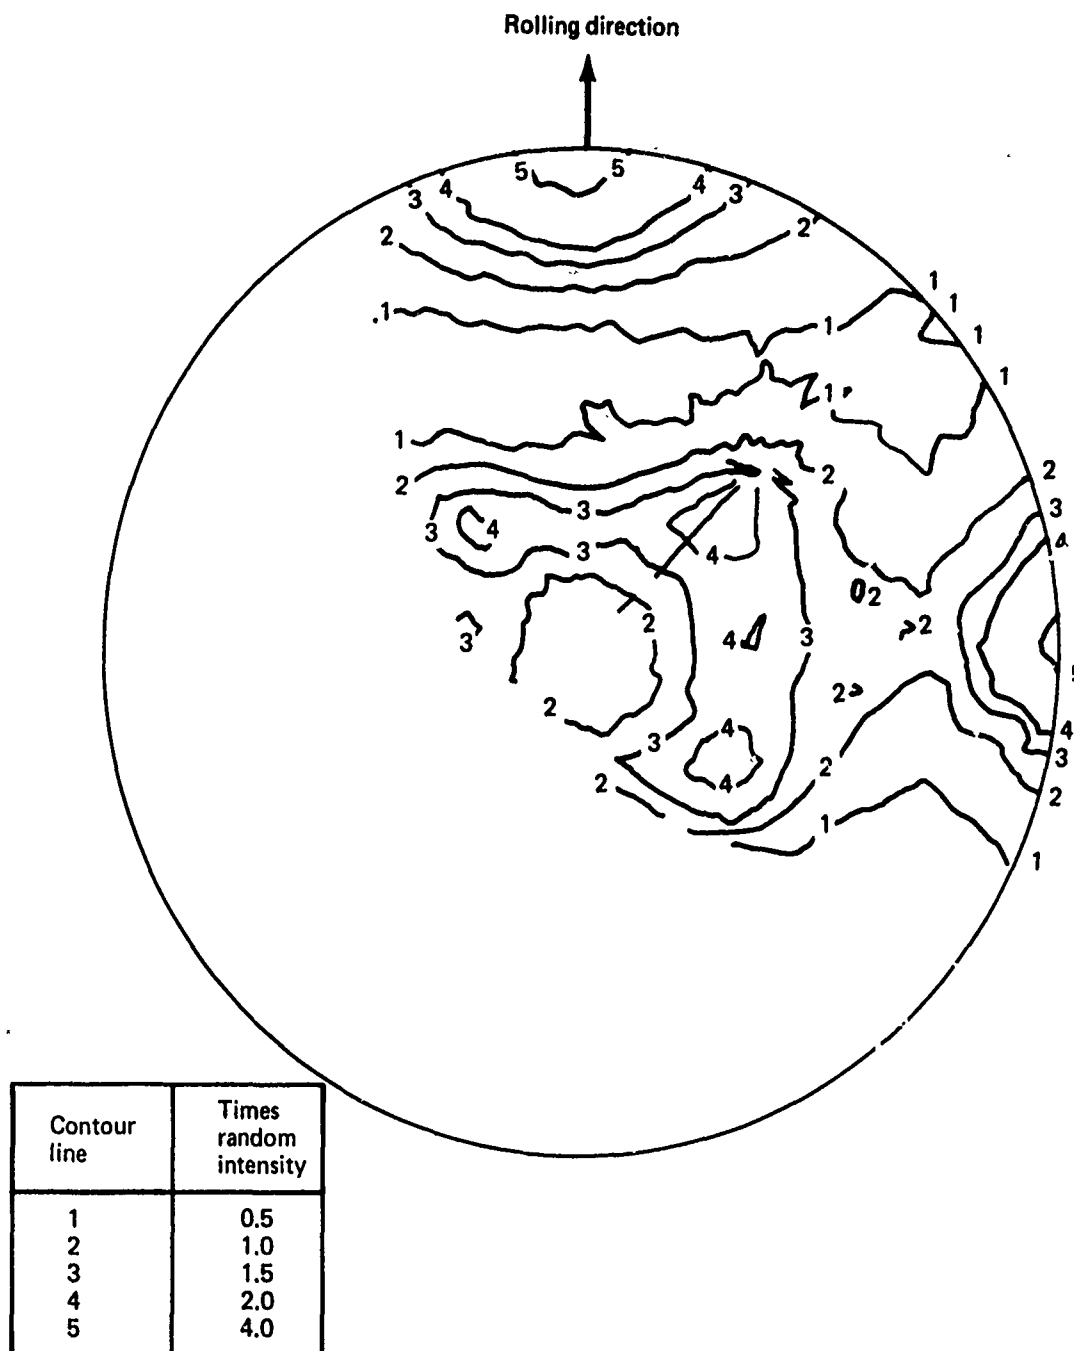
FIGURE 13.—TYPICAL BASAL PLANE POLE FIGURE FOR MILL-ANNEALED HAND MILL Ti-6Al-4V SHEET

more transverse texture (fig. 14) than mill-annealed sheet conditions I or V (fig. 13). This effect is also noted in sheet specimen FM 939, heat 310487 in table 11 where an extremely large amount of hydrogen pickup (100 ppm) was observed. This, coupled with the nominally high hydrogen content in the as-received condition, resulted in a very high and unsatisfactory level of 200 ppm after chemical milling. Very recent work has shown that the percentage of retained beta on this sheet (heat 310487) was 10%. This is twice as much as has normally been found in a wide variety of Ti-6Al-4V heat-treat conditions and forms and would markedly increase the susceptibility of the sheet to absorb hydrogen. Also, the texture of this sheet was very highly transverse, much like that observed in continuously rolled sheet (fig. 14). If the diffusion rate of hydrogen in alpha titanium is greater in a direction parallel to the basal plane than in a direction perpendicular to the basal plane, then hydrogen pickup during chemical milling would be expected to be higher with a transverse texture (fig. 14) than with a less directional texture (fig. 13). More work needs to be done in the areas of texture, microstructure, chemical composition, and retained beta effects with respect to hydrogen diffusion and pickup in commercial titanium alloys using commercial feasible chemical milling solutions.

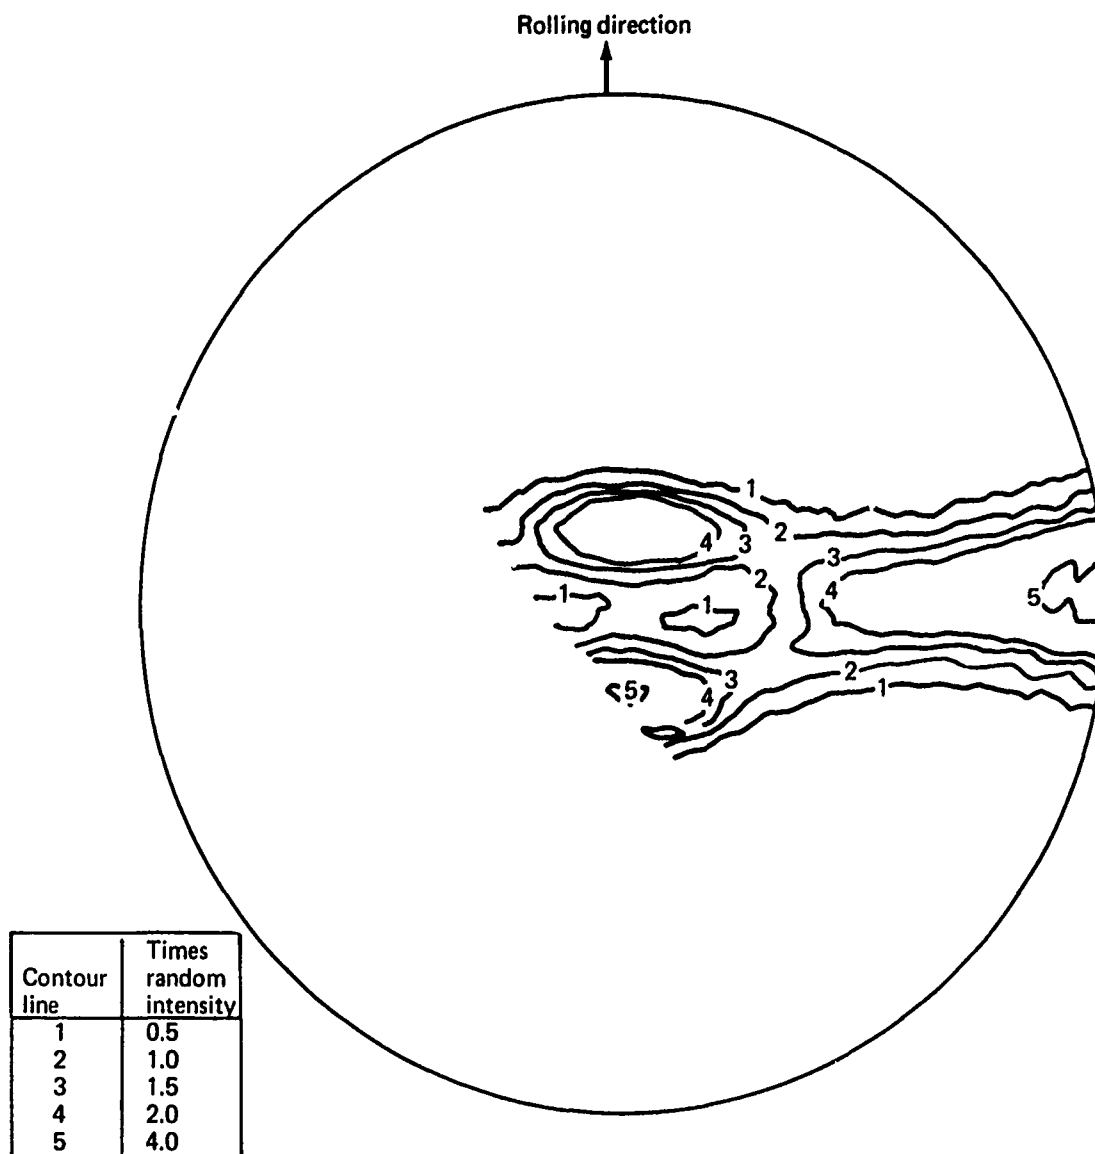
FIGURE 14.—TYPICAL BASAL PLANE POLE FIGURE FOR CONTINUOUSLY ROLLED AND ANNEALED Ti-6Al-4V SHEET

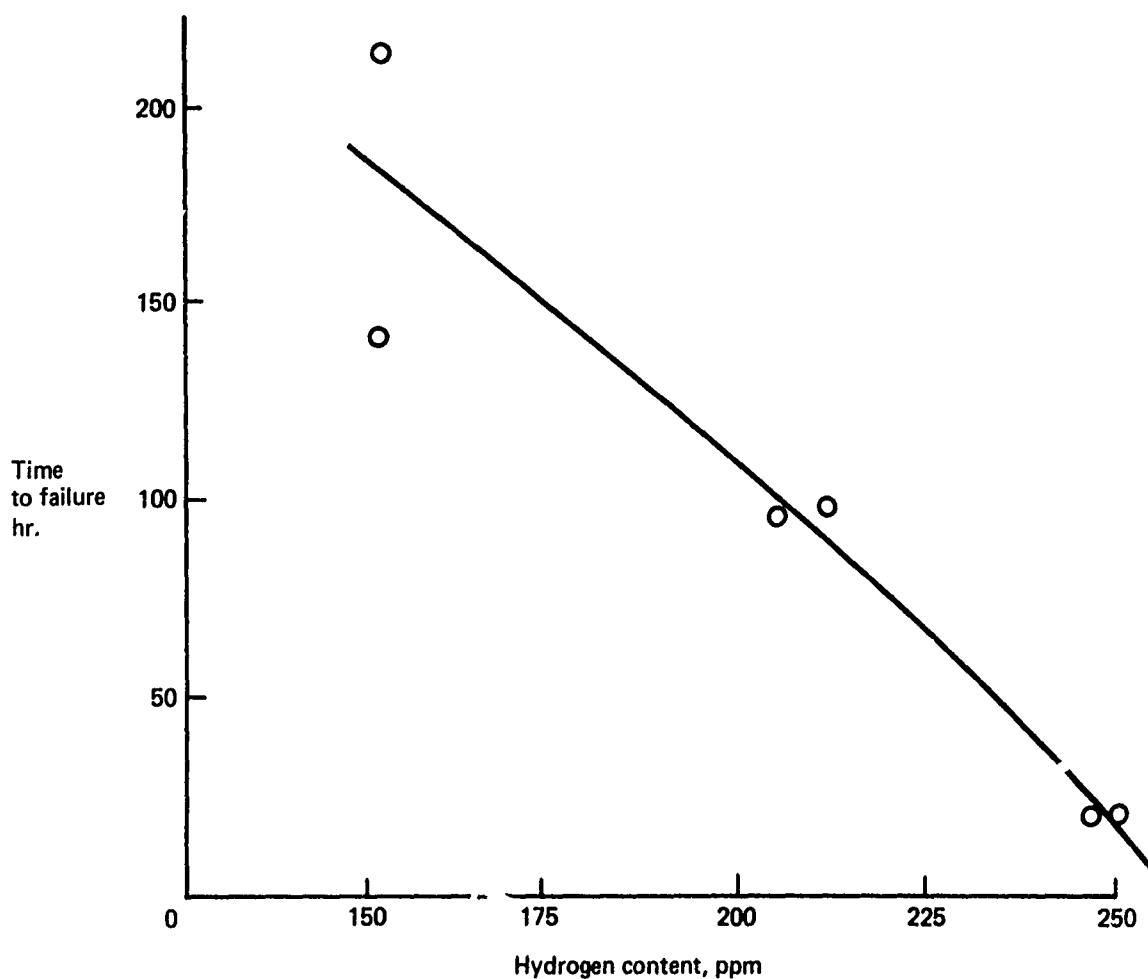
FIGURE 15.—EFFECT OF HYDROGEN CONTENT ON DELAYED FAILURE OF STA 1000°F Ti-6Al-4V PLATE LOADED AT 80% OF BASELINE K_{IC} —PRECRACKED CHARPY SPECIMEN

In the case of the more notch-sensitive, lower fracture toughness heat treatment condition, STA 1000°F, failures occurred in all specimens with hydrogen contents from 150-275 ppm. At 155 ppm H_2 , failures occurred in an average time of 177 hr at a K level of 80% of baseline and the failure time decreased sharply to 21 hr when the hydrogen was increased to 250 ppm. Figure 15 shows a graph of the effect of hydrogen content on the time to failure for STA 1000°F specimens loaded at approximately 80% baseline K. The actual K level at which the specimens were loaded increased slightly from 79.2% to 85.9% baseline as the hydrogen content increased from 156 to 250 ppm. This K level increase in itself would undoubtedly account for part of the decrease shown in figure 15. However, since the data in the beta-mill-annealed specimen showed this trend, they tend to substantiate that the delayed-failure resistance is reduced as the hydrogen content is increased from 150 to 250 ppm. More data would be required to provide a quantitative relationship.

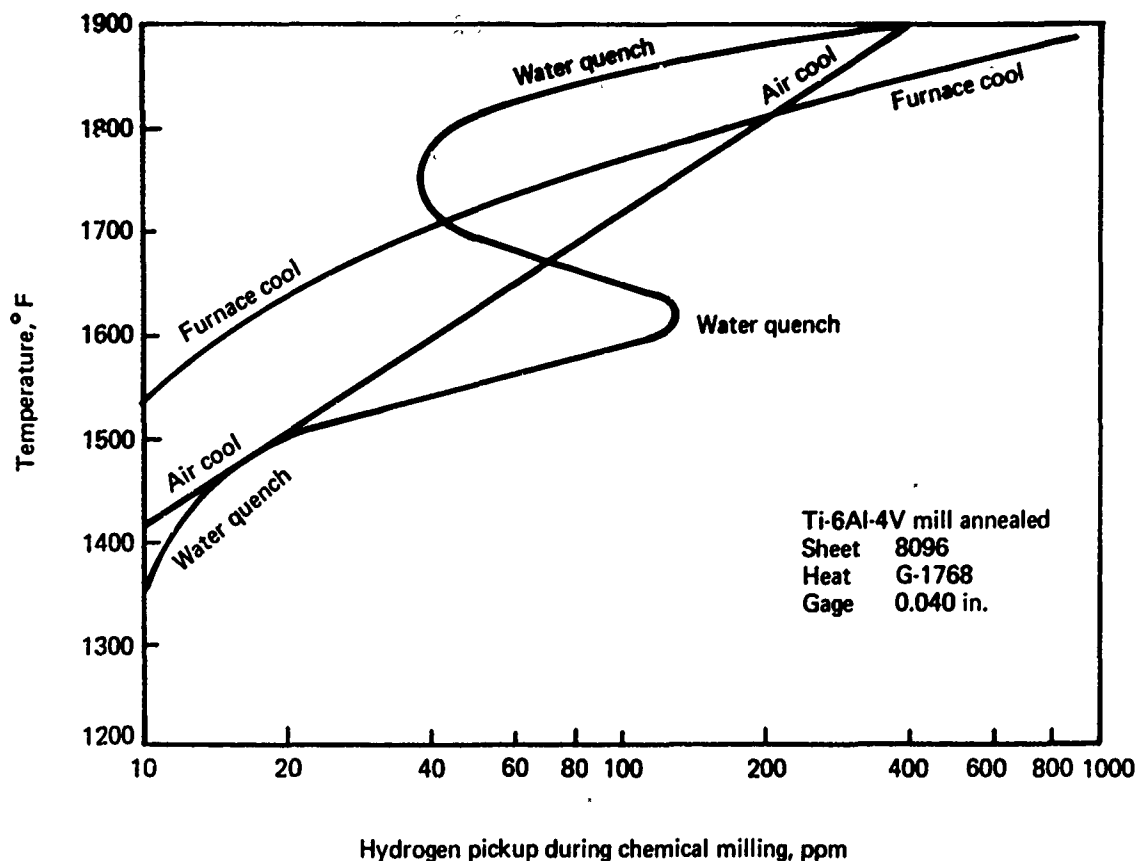
FIGURE 21.—EFFECT OF PRIOR THERMAL CYCLES ON THE SUSCEPTIBILITY OF Ti-6Al-4V TO HYDROGEN PICKUP DUE TO CHEMICAL MILLING (REF. 10)

The curves shown in figure 21 can be explained microstructurally. Since the diffusion rates and solubility of hydrogen in beta titanium (body-centered cubic, bcc) are much larger than those of alpha (hexagonal close-packed, hcp) titanium, the amount of hydrogen pickup during chemical milling will be related to the distribution of retained beta (beta phase at room temperature) in the Ti-6Al-4V being chemically milled. The distribution of retained beta in a transformed beta or Widmanstatten microstructure is very continuous with the beta phase outlining the alpha platelets (fig. 22a). This microstructure would allow hydrogen solution into the beta phase and diffusion throughout the material along the continuous beta network. Figure 22b shows an equiaxed alpha-plus-beta morphology obtained either by working the material below the beta transus to temperatures of approximately 1300°-1400° F or by alpha-beta working at higher temperatures (1600°-1700° F) and slow cooling. During the slow cooling (i.e., furnace cooling) the beta at temperature (50% beta at 1650° F) transforms as the material cools, but rather than forming a Widmanstatten structure as in figure 22a the equiaxed alpha particles grow as the percentage of beta decreases. As a result, the beta phase is concentrated at isolated triple points between equiaxed alpha grain boundaries and does not allow a continuous hydrogen diffusion path. If material is air cooled from 1650°-1750° F, the

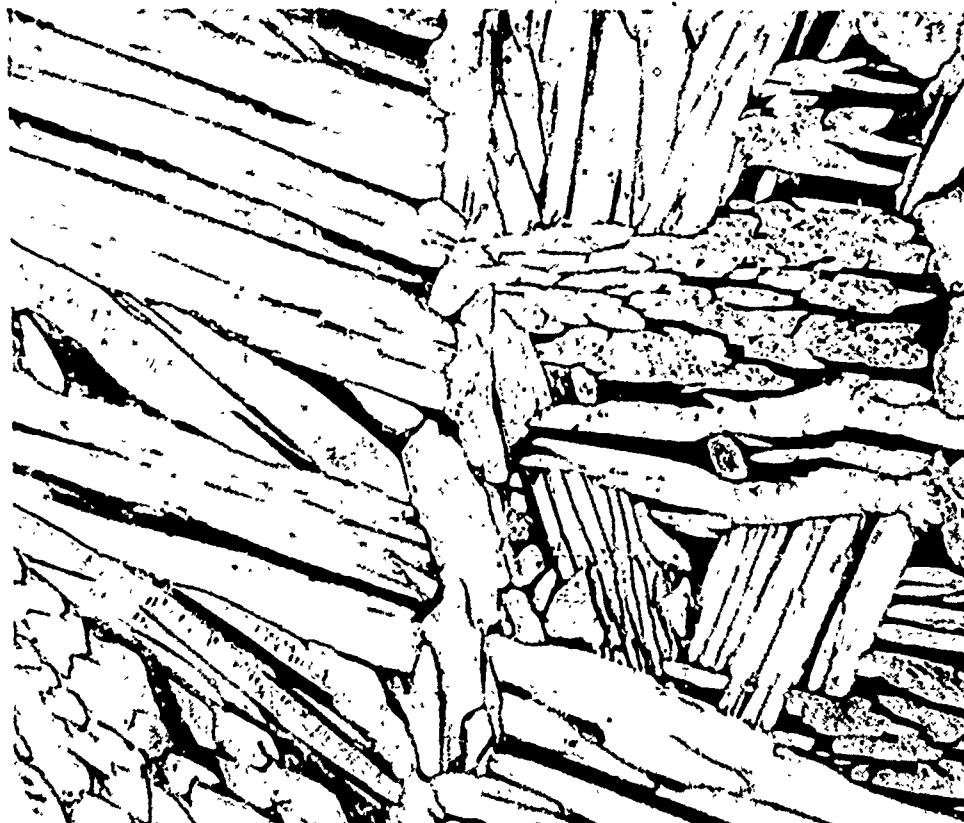
(a) Air Cooled From Above the Beta Transus (1900°F)

(b) Slow Cooled From Below the Beta Transus (1725°F)

FIGURE 22.—MICROSTRUCTURES OF Ti-6Al-4V AIR COOLED AND SLOW COOLED FROM ABOVE AND BELOW THE BETA TRANSUS (X 500)

(c) Slow Cooled From Above the Beta Transus (1900°F)

(d) Air Cooled From Below the Beta Transus (1725°F)

50%-70% beta at temperature transforms rapidly to a Widmanstatten structure since the equiaxed alpha does not have time to grow. A mixed or duplex structure results as shown in figure 22d. Figure 22c shows the microstructure of a material furnace cooled from 1900°F. Here the unworked alpha platelets retain their acicular shape but are much larger than material air cooled from above the beta transus. This explains the tendency for the air cooled material to pick up more hydrogen than the furnace-cooled material for a given temperature as shown in figure 21. In the former the beta phase is much more continuous, allowing for more rapid hydrogen diffusion along these beta paths. Also, the tendency for the totally transformed structures (figs. 22a and 22c) to pick up more hydrogen is explained in this manner. This totally transformed structure is present in any of the materials with a prior beta cycle (1900°F/30 min/air cool).

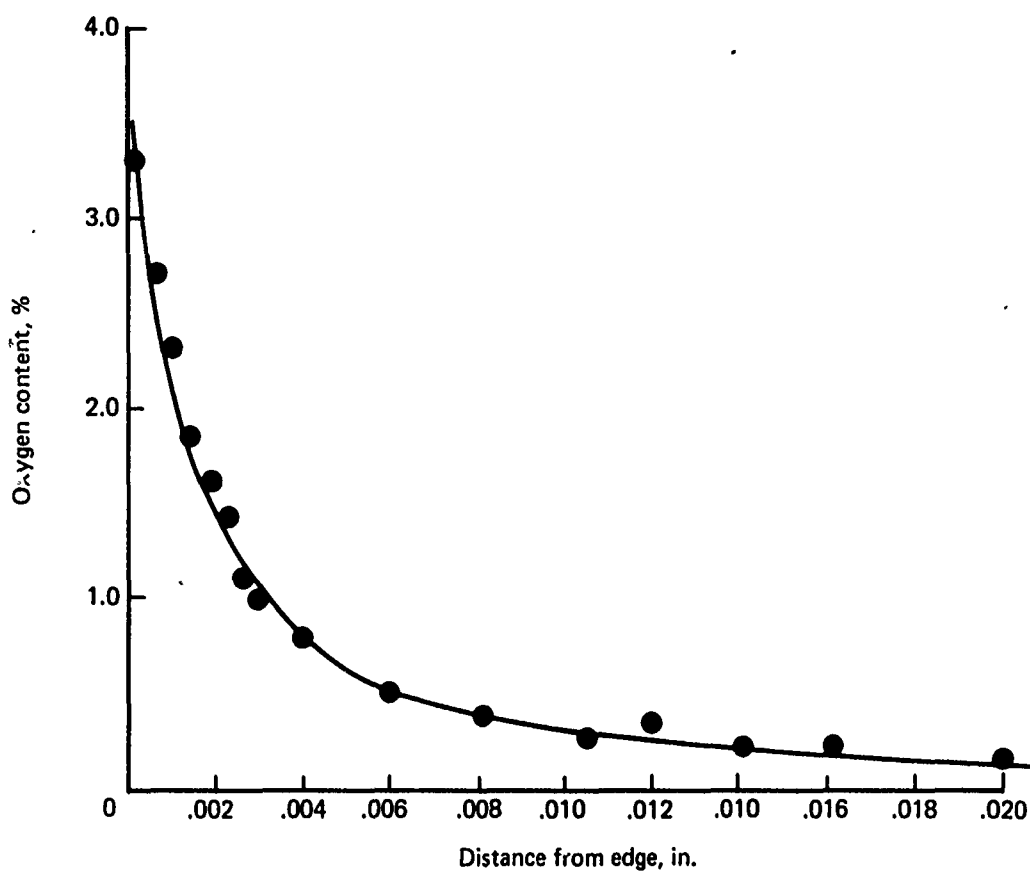
FIGURE 23.—OXYGEN GRADIENT IN Ti-6Al-4V AFTER EXPOSURE TO AIR AT 1800°F FOR 2 HR

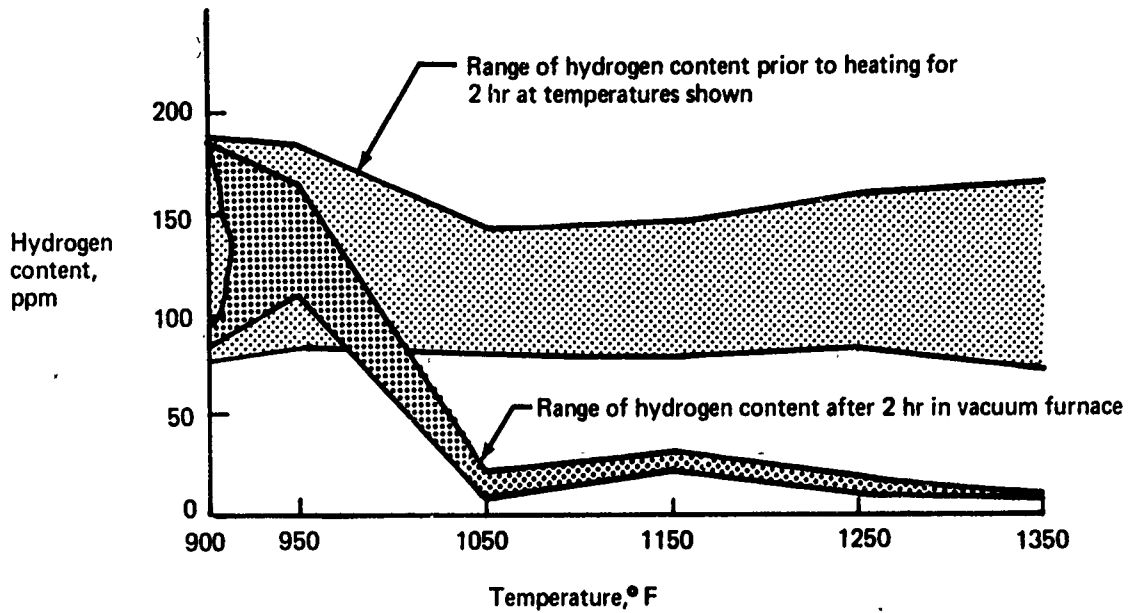
All specimens chemically milled to final gage to raise hydrogen content.
 Data derived from four specimens (two gages, two sheets)
 at each temperature shown (900°, 950°, 1050°, 1150°, 1250°, 1350°F)
 Vacuum: 10^{-4} torr, minimum

FIGURE 24.—HYDROGEN DEGASSING TESTS IN VACUUM FURNACE

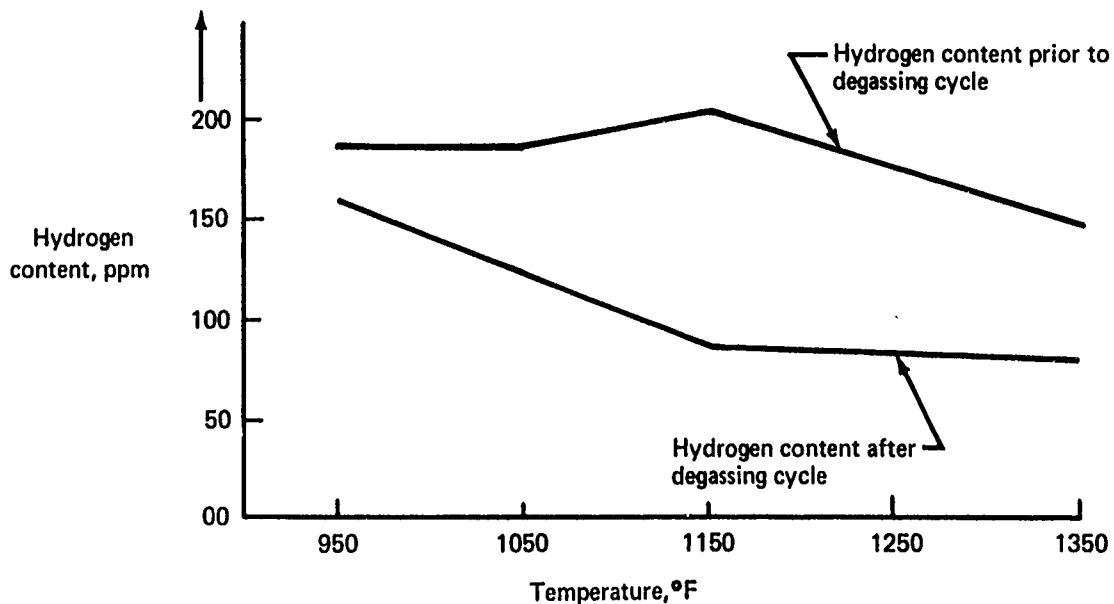
Cycle: 50 torr vacuum for 1 hr at temperatures 950°, 1050°, 1150°, 1250°, 1350°F

FIGURE 25.—HYDROGEN DEGASSING TESTS IN 12-BY 12-IN. RETORT
